ASSESSMENT OF CORRECTIVE MEASURES REPORT – DRAFT

**Trimble Road Landfill (Permit #333),
Fort Pickett, Nottoway County, Virginia**

USACE Contract: W912QR20D0008
Delivery Order: W912QR22F0180

DRAFT - Revision 1, October 2022

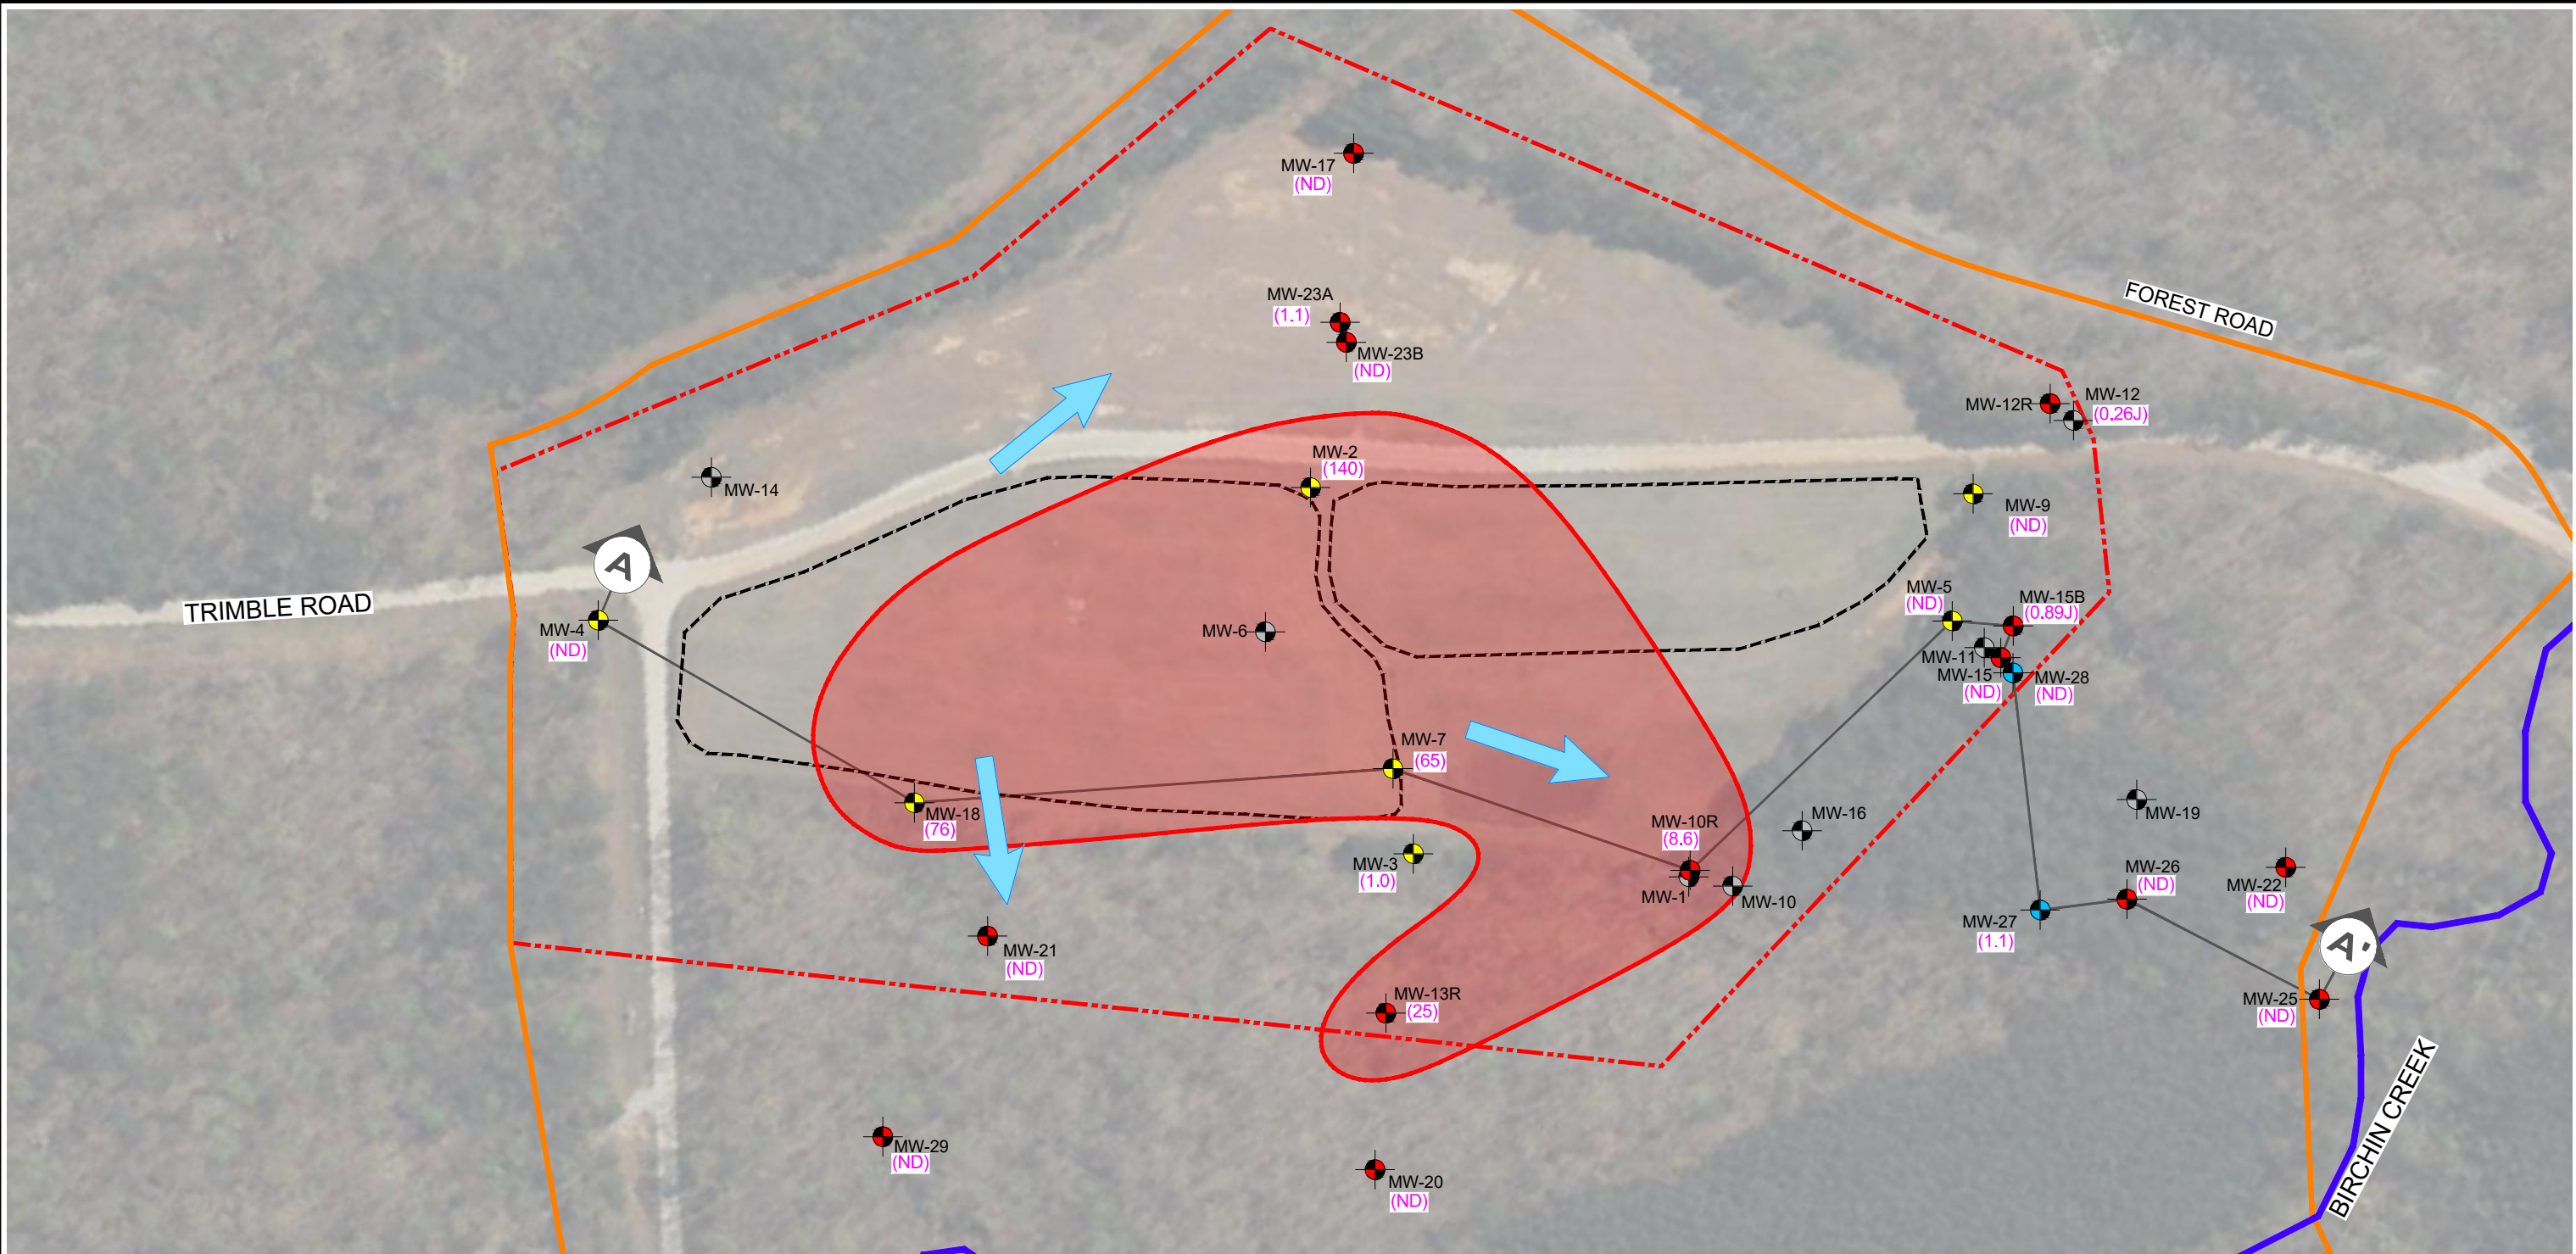
- MW-2 COMPLIANCE MONITORING WELL
- MW-1 SENTINEL MONITORING WELL
- MW-27 PERFORMANCE MONITORING WELL
- MW-6 ADDITIONAL SITE MONITORING WELL (NOT SAMPLED)
- BIRCHIN CREEK
- APPARENT DIRECTION OF GROUNDWATER FLOW
- INTERPRETED EXTENT OF GPS EXCEEDANCES OF COBALT
- CURRENT WASTE MANAGEMENT BOUNDARY
- FACILITY BOUNDARY
- DISPOSAL UNIT BOUNDARY
- COBALT CONCENTRATION (ug/L)
- CROSS SECTION
